**HURRICANE KATRINA:
WHY DID THE LEVEES FAIL?**

**COMMITTEE ON
HOMELAND SECURITY AND
GOVERNMENTAL AFFAIRS
UNITED STATES SENATE**

NOVEMBER 2, 2005

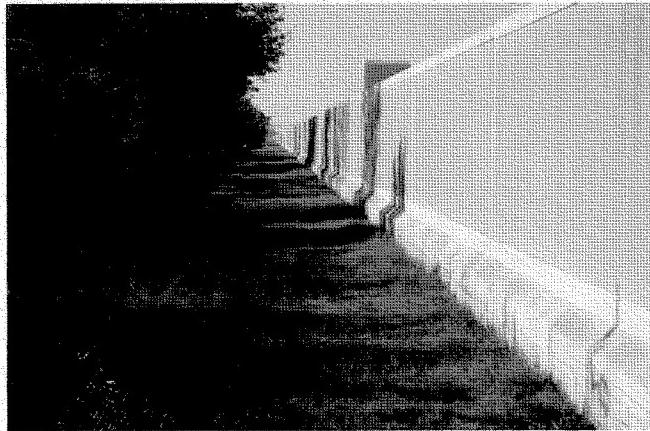
Figure 2.11: Typical conditions at the inboard side of floodwalls along the 17th Street Canal showing no scour of soil at the toe of the wall.

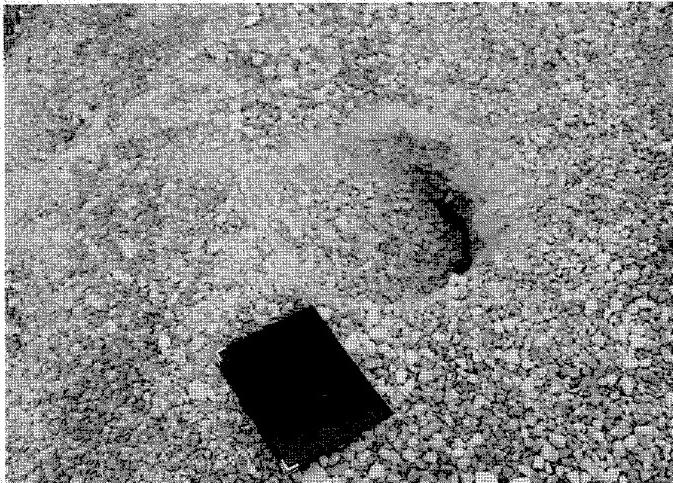
Figure 2.13: One of four sinkholes noted at the front lip of the crest of the temporary closure section embankment.

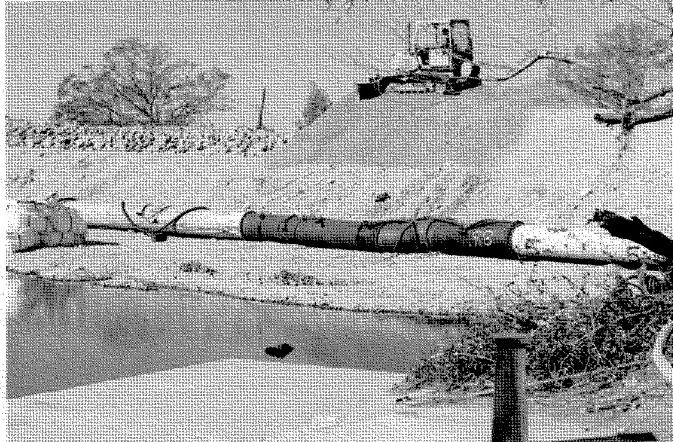
Figure 2.14: Placement of silty sand fill at the crest and on both the inboard and outboard faces of the temporary embankment closure section on October 6, 2005.

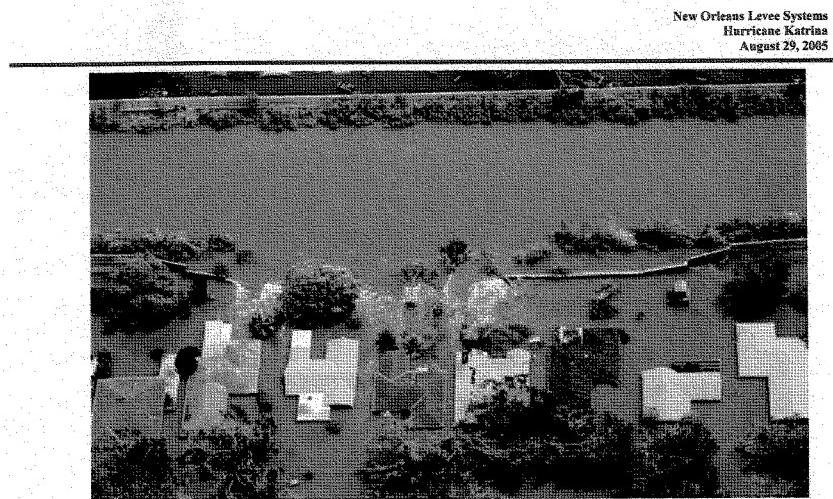
Figure 2.15: The breach section at the west side of the London Avenue Canal (North).

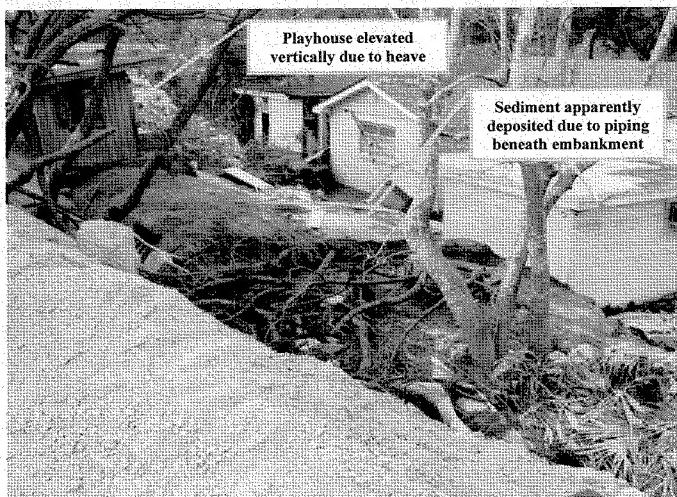
Figure 2.16: Conditions at the inboard toe of the London Avenue Canal (North) breach section.

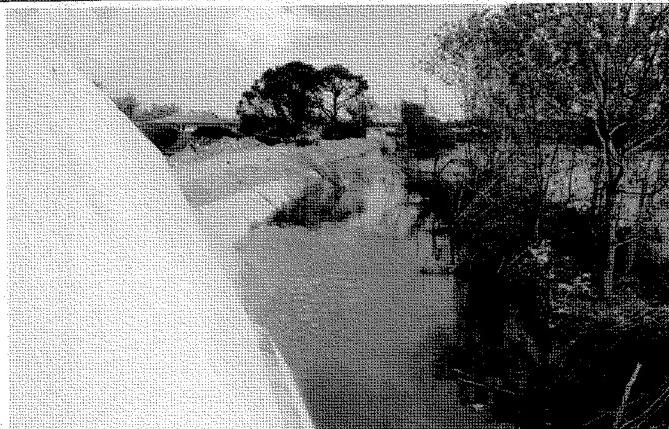
Figure 2.17: The toppled floodwall/sheetpile walls at the London Avenue Canal (North) breach site.

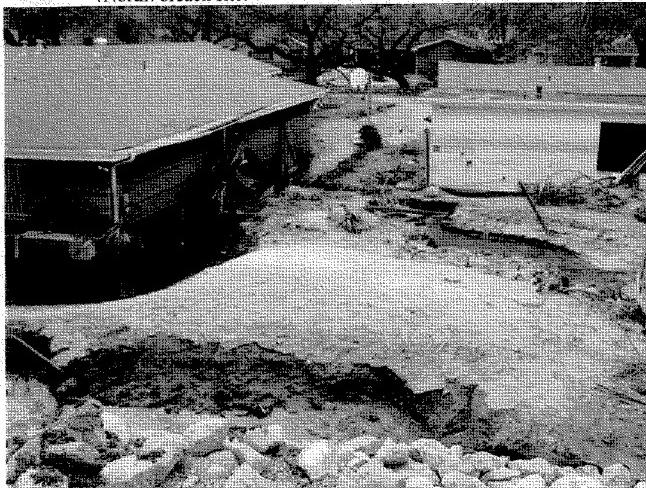
Figure 2.18: Sediment from the London Avenue Canal was deposited inboard of the levee break. High water marks (from long-term ponding) are visible on the exteriors of the residential homes.

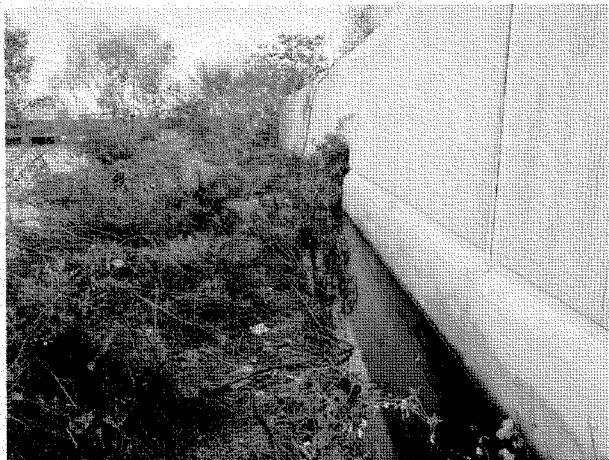
Figure 2.19: Gap at the base of the floodwall on the canal side of the East Bank “distressed” section.

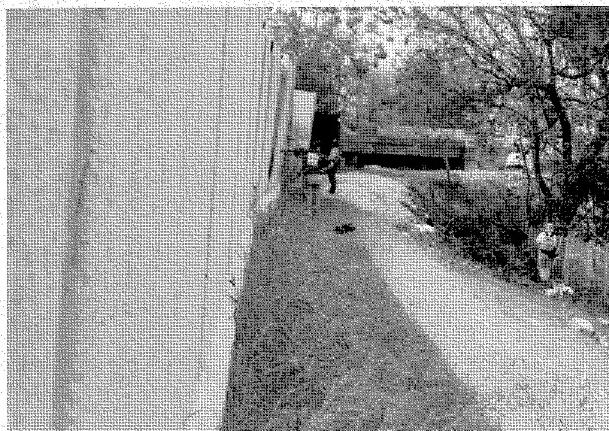
Figure 2.20: View of the inboard side of the floodwall and earthen levee embankment.

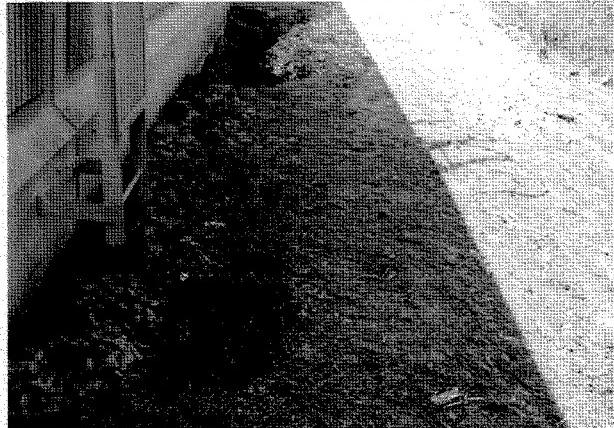
Figure 2.21: Closeup view of sinkholes at the inboard toe of the floodwall, at the location of the engineer wearing a red shirt in Figure 2.20.

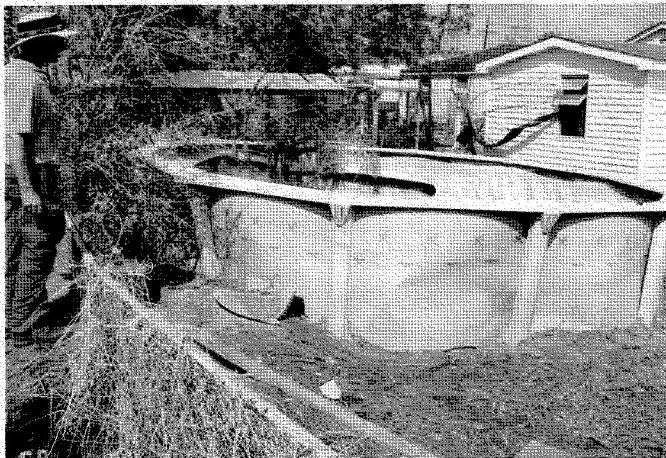
Figure 2.22: View of conditions at the inboard toe, immediately inboard of the locations shown previously in Figures 2.21 and 2.22. Note the bulged and hummocky ground, the laterally displaced chain link fence, and the piping boil ejecta.

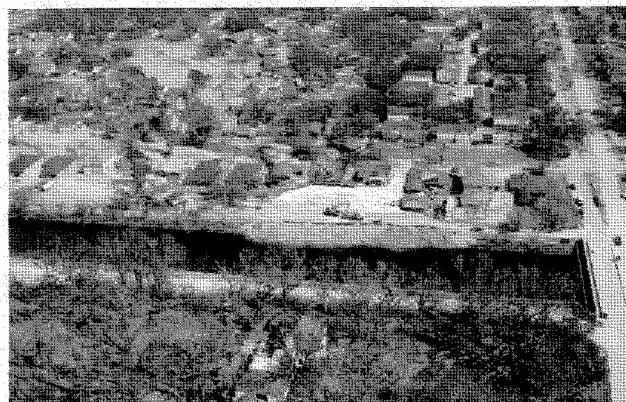
Figure 2.24: Aerial view of the breach section at London Avenue Canal (South).

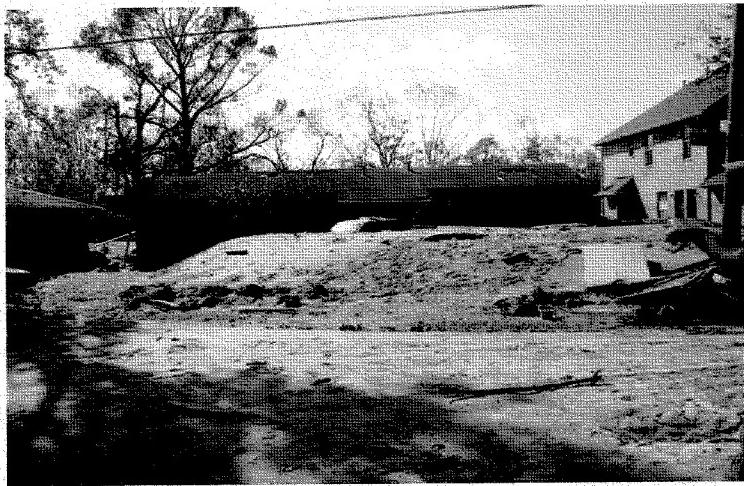
Figure 2.26: Significant quantities of sediment were deposited in the residential neighborhoods on the east side of the London Avenue Canal. More than five feet of sediment was deposited around this home.

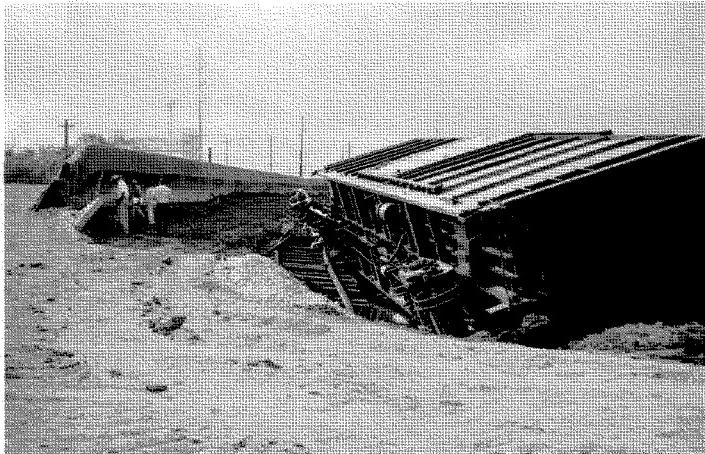
Figure 2.27: Breached levee floodwall section at Location "A" along the west side of the INHC.

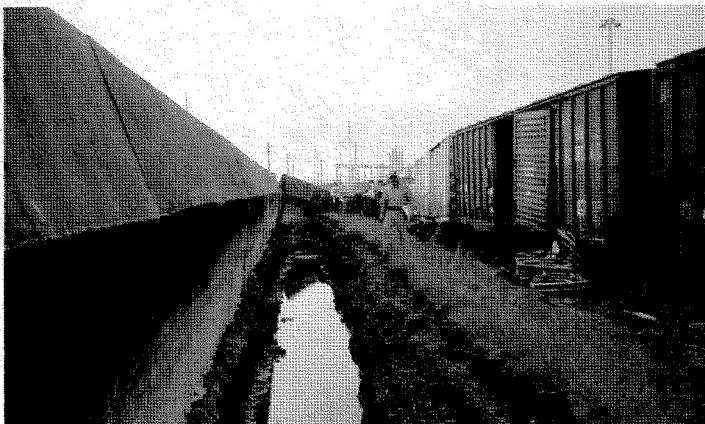
Figure 2.28: Erosion at the inboard toe of concrete floodwalls at Location "A" along the west side of the INHC, adjacent to the breached section shown previously in Figure 2.27.

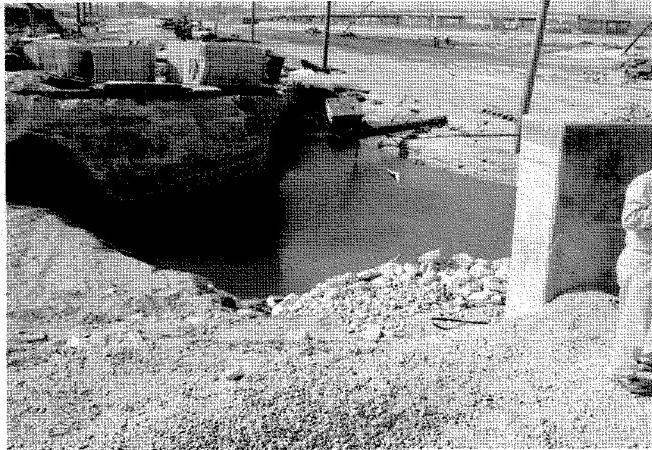
Figure 2.29: Erosion at a "transition" between a concrete floodgate wall and the adjacent earthen embankment section.

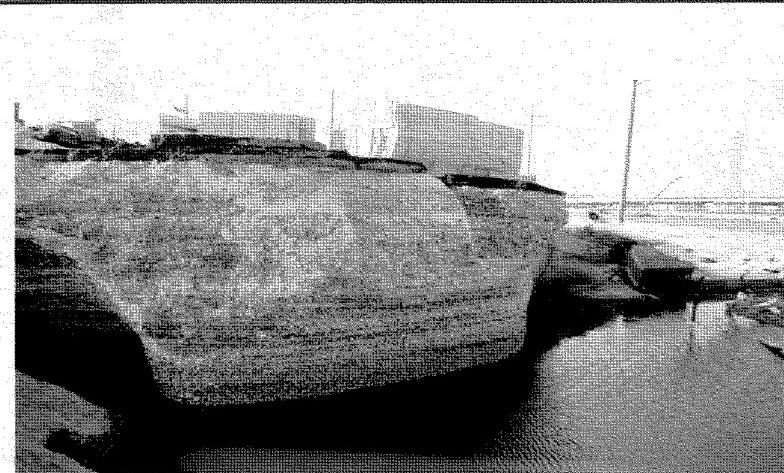
Figure 2.31: Close-up view of sandy "shell" fill at the scoured edge of the breach shown previously in Figure 2.29.

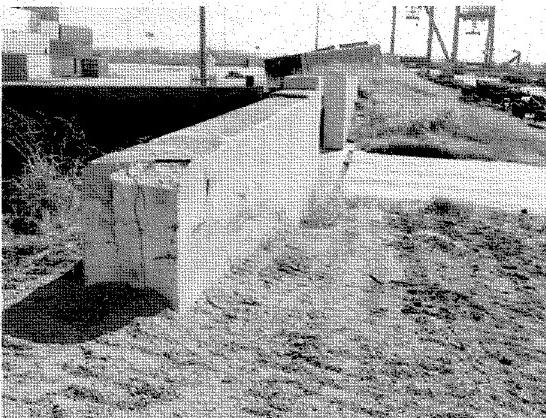
Figure 2.32 shows an additional example of this type of “transition” deficiency between a structural (concrete) wall and adjacent earthen levees, just a bit farther to the east at Location “C” in Figure 2.1(a).

Figure 2.32: Common structural wall (with flood gate) and earthen levee transition problem with erosion at the contact between the earth and concrete sections.

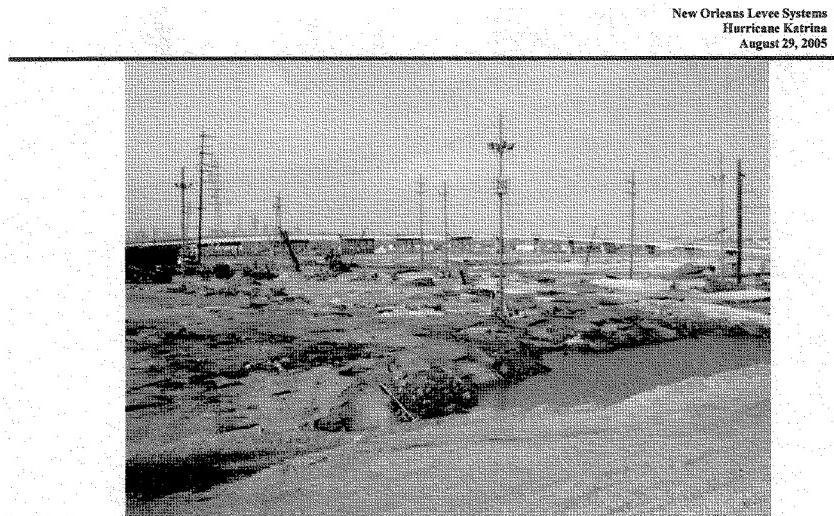
Figure 2.33: Scour hole and deposits of sediment and shells, inboard of the breach shown previously in Figure 2.32.

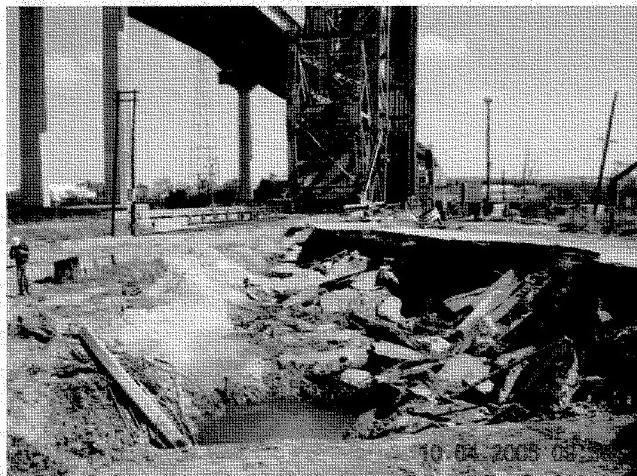
Figure 2.34: A complex “transition” involving several overlapping operations and penetrations through the flood protection levees immediately south of the I-10 bridge across the IHNC.

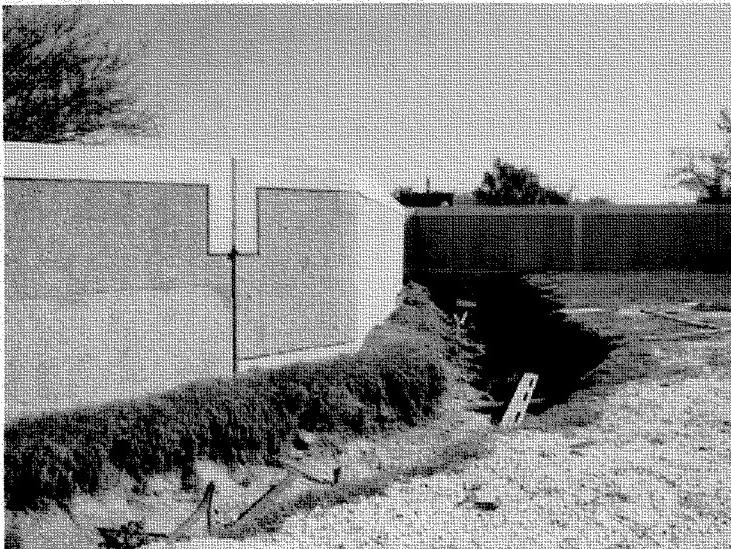
I-wall sections on the lakefront side appeared to have been overtopped, or to have at least experienced significant splash over, as evidenced by scour on the protected side of the walls and debris both on and behind the walls. Inspection of these wall sections showed little to no distress despite the significant scouring at places (Figure 3.3). This was in contrast to many other I-wall sections that had either been severely distressed or failed. It appeared that the construction of the I-wall sections in this area were significantly more robust than those other sections with damage. The walls appeared to be newer than most of the other I-wall observed in New Orleans East, with uniformly thicker and taller concrete sections. The section of floodwall that paralleled the shoreline was exposed to waves generated in Lake Pontchartrain. The scour trenches behind the walls parallel to the shorefront were relatively wide and deep. Interestingly, the scour behind wall sections perpendicular to the shorefront were smaller, an apparent result of the absence of waves reaching those sections.

Figure 3.3: I-wall adjacent to the Lakefront Airport showing deep back-scour but no evidence of distress to the wall.

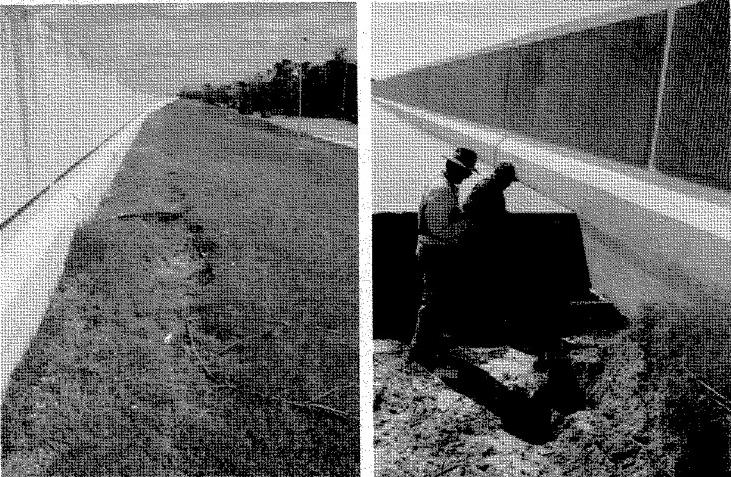
Figure 3.4: Beginning of overtopping scour along lakefront flood wall suggests moderate overtopping at this location.

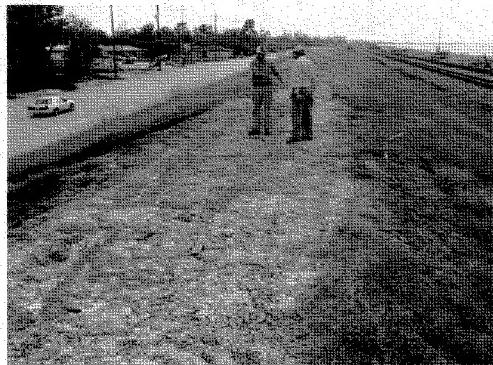
Figure 3.6: Wave overtopping of lakefront earthen levee at low spot in structure did not cause serious damage (N 30° 03' 47.8", W 89° 58' 13.1")

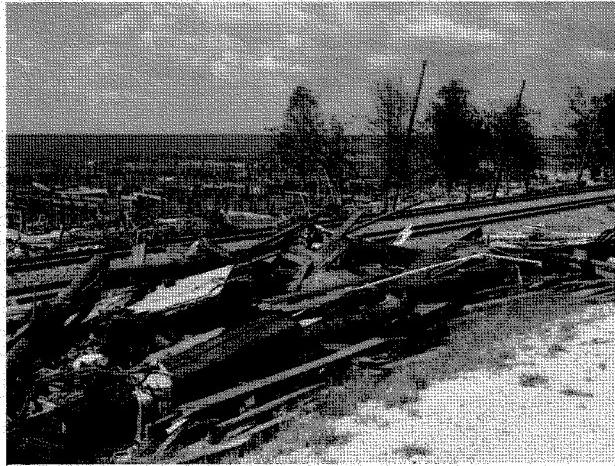
Further to the east, beyond Paris Road, the lakefront community of Little Woods located lakeside of the levee was almost completely demolished by the wind and storm waters (Figure 3.7). Figure 3.8 shows debris from the demolished structures left very near the levee crest, indicating a high water level consistent with other water lines we observed in the lakefront area. Debris from the houses was also strewn on the landside of the levee in a pattern that suggested wind transport. Figure 3.9 shows the only surviving structure at Little Woods, which was noticeably elevated on piles. It appears intact except for the absence of stairs to reach the elevated balcony, suggesting that the building industry can construct structures that resist storm forces like the ones experienced during Hurricane Katrina at Little Woods.

Figure 3.7: The lakefront community of Little Woods destroyed by wind and water (N 30° 04' 70.5", W 89° 56' 44.0")

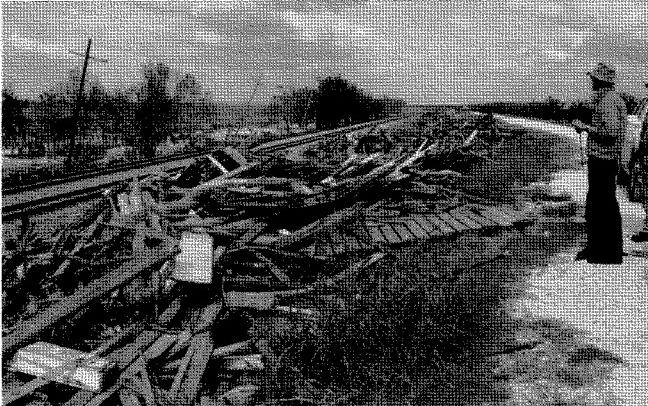
Figure 3.8: Debris from the Little Woods houses accumulated near the crest of the earth levee indicates the level of the lake waters during the storm. (N 30° 04' 70.5", W 89° 56' 44.0")

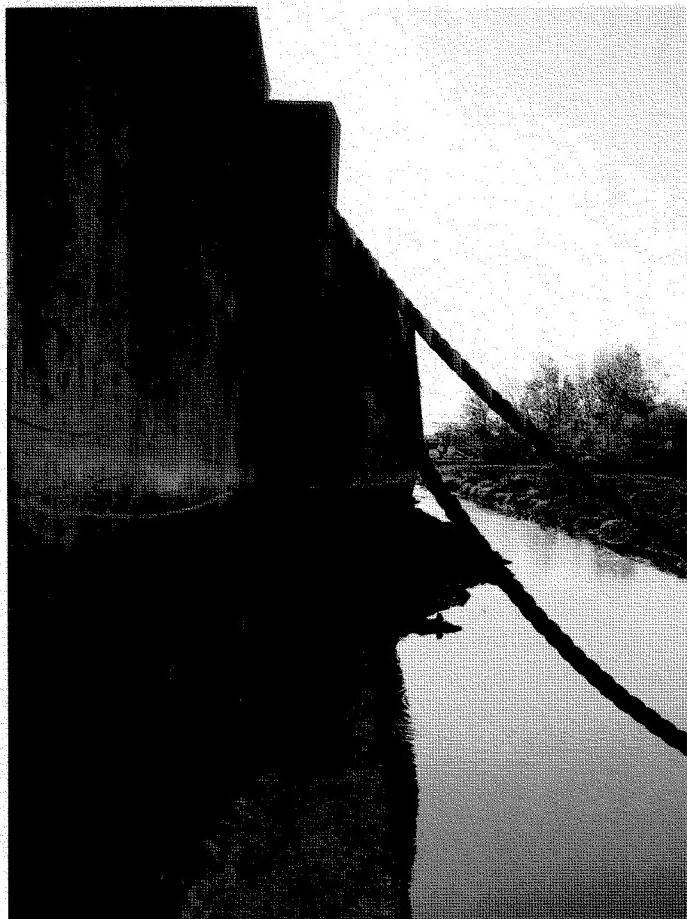
Some sections of the I-walls along the southern boundary of New Orleans East, on the IWW/MRGO, were observed to have failed while others remained standing either in good working order or in various states of distress. Virtually all of the I-walls had been overtopped, and the soil behind them significantly scoured (Figure 3.10). The various states of distress (and failures) appeared to be for the most part related to the loss of passive resistance resulting from the scour (Figure 3.11). Those that were in distress but not failed also showed gapping between the wall and the soil foundation on the waterside (Figure 3.12). This waterside gap would also assist in destabilizing the walls by reducing support of the sheet piles beneath the concrete wall sections. Where there were T-walls we observed no significant distress to the walls. In general, the T-wall sections appeared to be used only adjacent to gate structures and pumping facilities. Figure 3.10 also shows an example of a T-wall adjacent to an I-wall on the IWW/MRGO. The T-wall showed no apparent distress.

Figure 3.10: Undamaged T-wall in foreground and damaged I-wall in background along the IWW/MRGGO. Severe scour on the landside and distress of the I-wall (N30.00030 W89.99459).

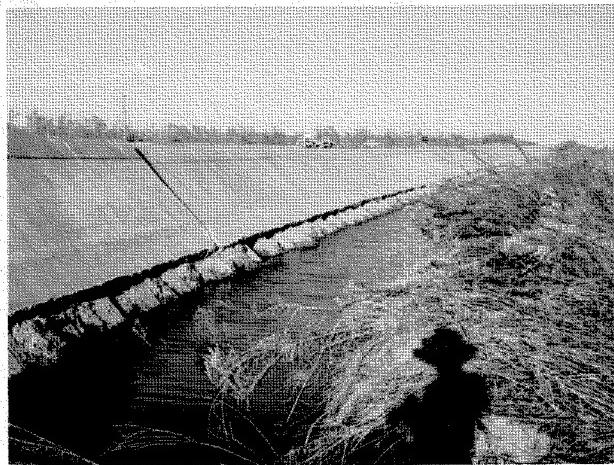
Figure 3.11: Severely distressed I-wall after overtopping from the water side along the IWW/MRGO.

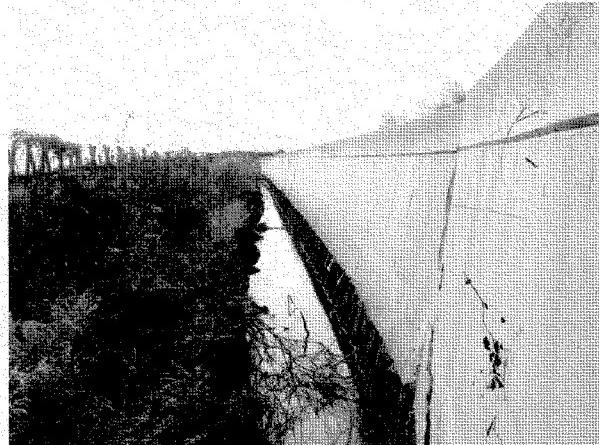
Figure 3.12: "Gapping" between soil and wall as distressed wall was displaced landward from the IWW/MRGO.

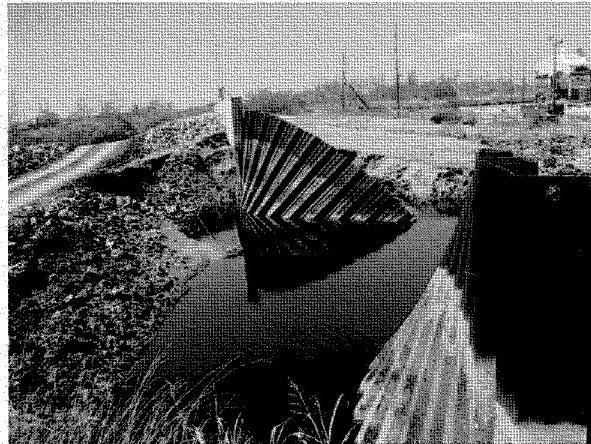
Figure 3.13 Failure of sheetpile wall adjacent to higher and stronger concrete topped I-wall on the north side of the IWW.

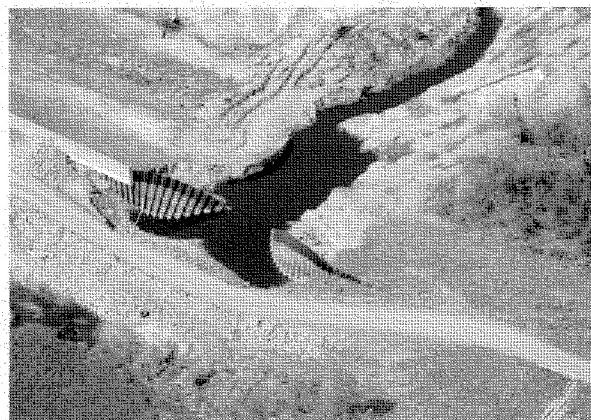
Figure 3.14: Aerial view of the failed wall section shown in Figure 3.14.

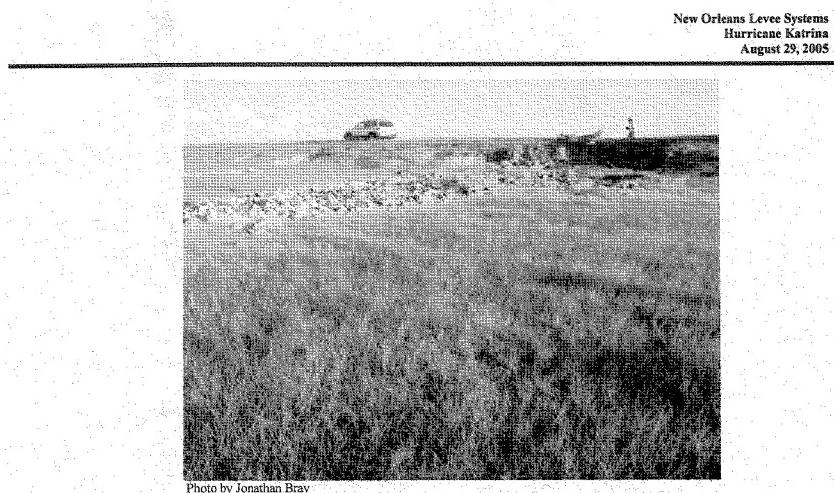
Figure 3.15: Embankment along the IWW/MRGO that survived although somewhat scoured.

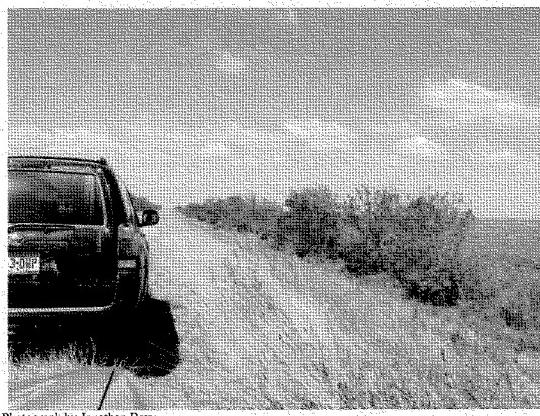
The earth levee along the north bank of the Intracoastal Waterway under the Route 47 Bridge stands as an example of satisfactory performance despite hydraulic conditions that far exceeded the design criteria. Figure 3.17 shows the erosion damage on the landside slope of the levee due to the overtopping. Figure 3.18, taken from the Entergy Michoud Generating Plant, shows the area in Figure 3.17 under storm conditions. Given the ferocity of the storm as evidenced in Figure 3.18, the relatively modest damage to the earth levee represents satisfactory performance.

Figure 3.17: Earth levee beneath the north abutment of the Route 47 Bridge over the IWW/MRGO, next to the Entergy Michoud Generating Plant, looking south. Despite considerable damage, the levee performed satisfactorily during and after overtopping.

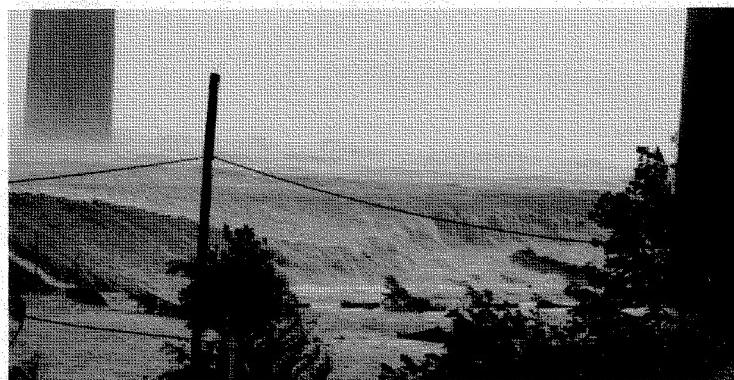
Figure 3.18: Same view of the overtopped earth embankment as seen in Figure 3.18 taken during the storm surge.

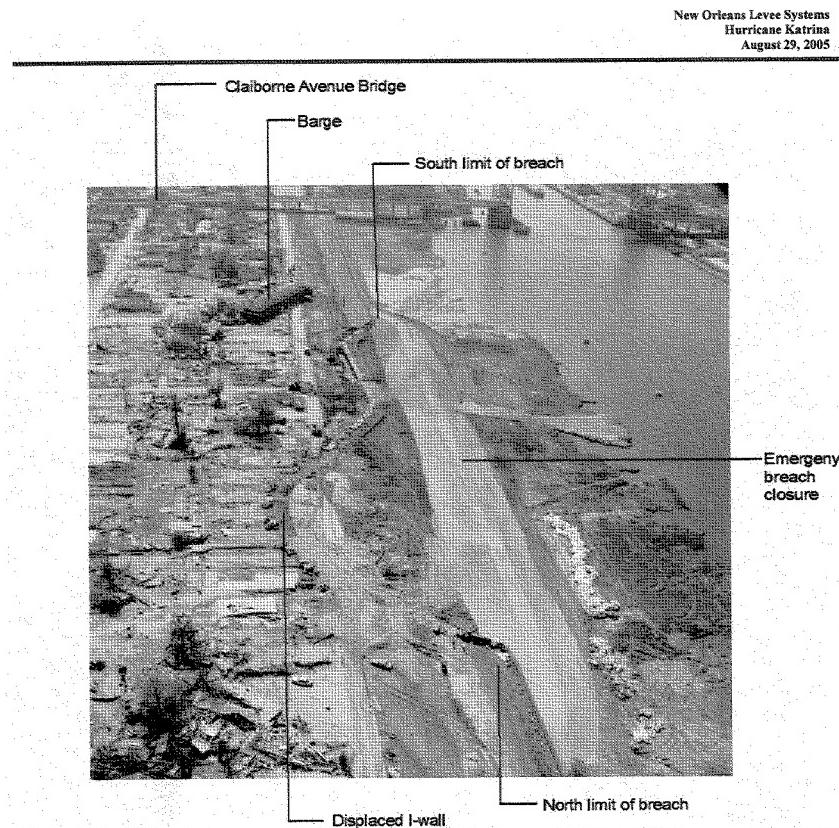
Figure 4.2: Aerial view of the south breach at the Lower Ninth Ward (L. Harder, October 14, 2005).

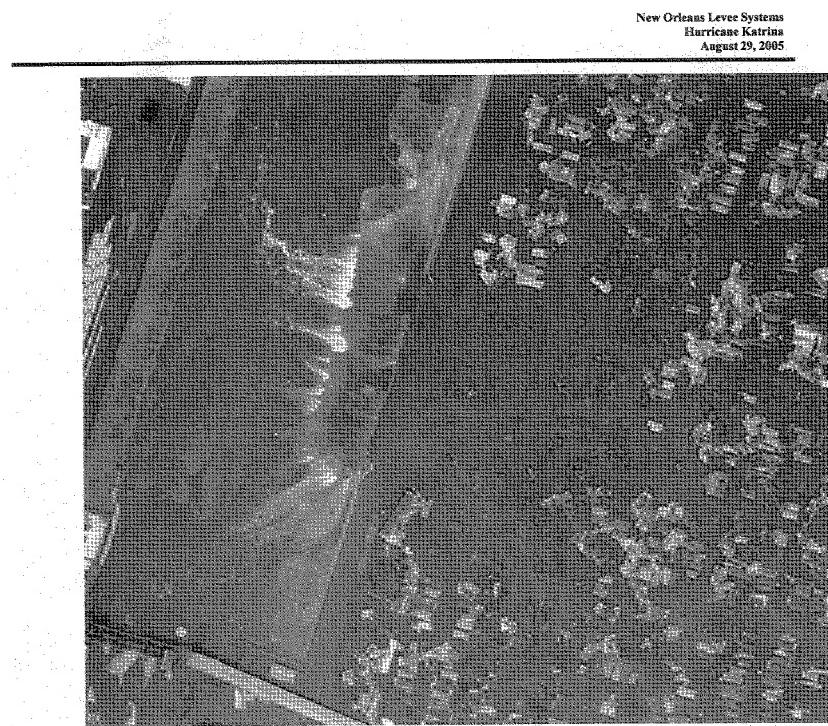
Figures 4.2 and 4.3 show aerial views of an approximately 900 feet long levee breach located 850 feet north of the Claiborne Avenue Bridge. The breach initially resulted from the Hurricane Katrina storm surge in the IHNC. An emergency repair was made shortly after the breach occurred. This repaired portion of the breach was later re-breached on September 24 by a storm surge caused by Hurricane Rita, which flooded the Lower Ninth Ward for a second time. This second flooding incident was reportedly much less severe than that caused by Hurricane Katrina (floodwaters reached a depth of about 3 feet), and as such, it is likely that it caused relatively little, if any, additional damage to the levee system at this location.

Figure 4.3: Airborne digital imagery of the south breach at the Lower Ninth Ward. Water is shown flowing back into the IHNC (courtesy NOAA, August 31, 2005).

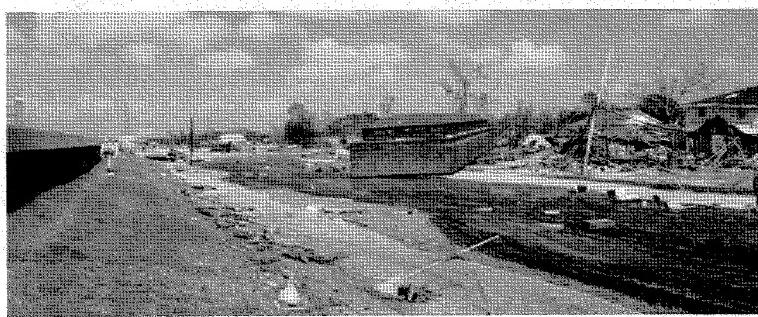
Figure 4.5 shows a unique feature of the failure site: a large barge that was drawn through the breach and came to rest on the landside of the levee as floodwaters receded. The barge was reportedly docked in the IHNC and became unmoored during Hurricane Katrina. Note the crushed school bus under the right side of the barge. Review of press photographs indicate that the barge initially came to rest further inland as floodwaters from Hurricane Katrina receded. The barge was later refloated as the Ninth Ward flooded a second time during Hurricane Rita. The barge drifted back toward the breach and came to rest upon the school bus as the Lower Ninth Ward was later unwatered.

Figure 4.5: A barge was drawn through the south breach of the Lower Ninth Ward (J. Wartman, October 4, 2005).

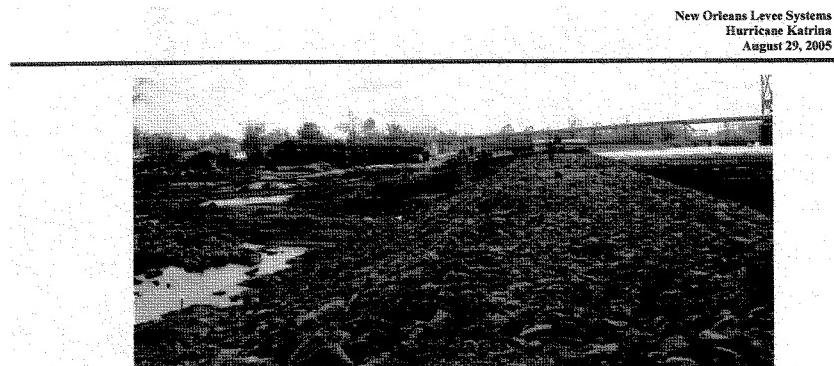
Figure 4.6: South view of the south breach repair at the Lower Ninth Ward (J. Wartman, October 4, 2005).

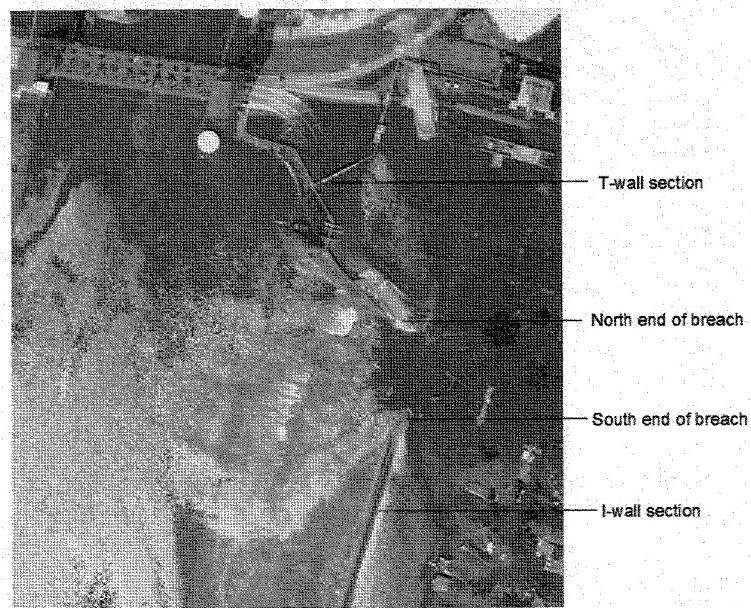
Figure 4.7: Airborne digital imagery of the north breach at the Lower Ninth Ward. Water is shown flowing back into the IHNC (courtesy NOAA, August 31, 2005).

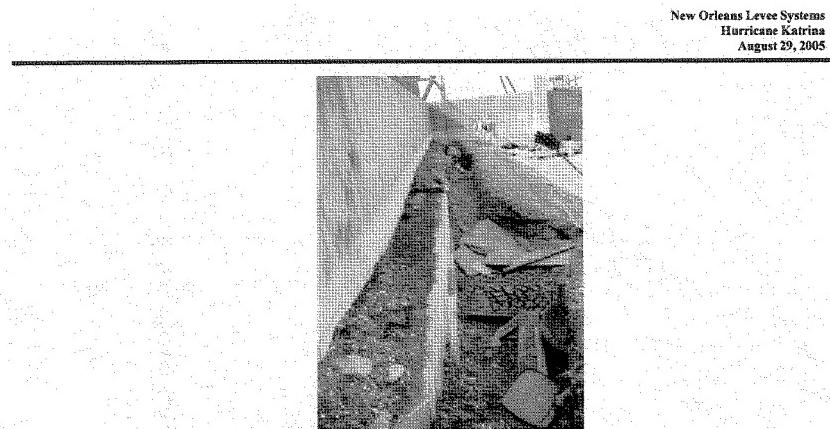
The unbreached portions of the I-wall system located immediately south of the failure were tilted inward (landward). The tilted I-walls reached their maximum inclination of approximately 3 degrees near the breach and gradually tapered to close to vertical at further distances to the south. Scour trenches at the landside toe of the floodwall (protected side) were found along the entire length of the intact I-wall section. The scour trenches were typically about 5 feet wide at the top and extended to depths of approximately 3 to 4 feet. As with the south breach, the scour trenches were wide and u-shaped near the breached area and gradually became narrower, v-shaped and incised at greater distances. Scour was also noted along the landside of the T-wall levee sections (Figure 4.8).

Figure 4.8: A scoured, but nevertheless well-performing "T-wall" levee section located near the north breach of the Lower Ninth Ward (J. Wartman, October 4, 2005).

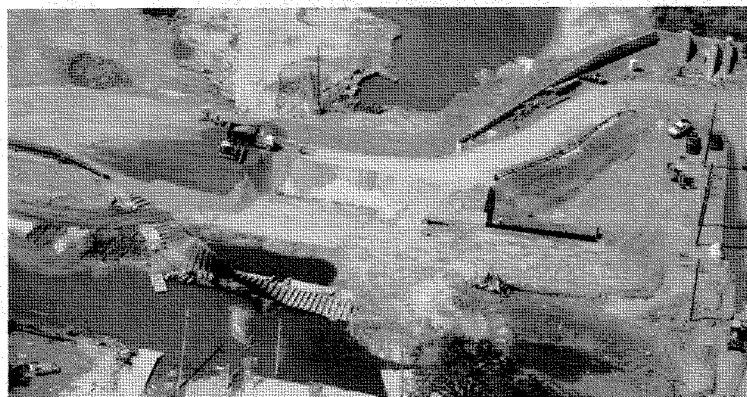
Figure 4.9 shows an aerial view of a 210 foot long levee breach located approximately 500 feet south of Florida Avenue. The breach initially resulted from the Hurricane Katrina storm surge in the IHNC. An emergency repair was made soon after. It is reported that unlike the south breach location, the north breach emergency repair was not overtopped in Hurricane Rita. The earthen portion of the I-wall levee system was almost completely destroyed and the I-wall was overturned and dragged inland by as much as 70 feet while remaining fully interlocked. In the most extreme case, the I-wall came to rest upside down, with the concrete portion at the bottom, and the toe of the sheeting pointing upward (Figure 4.10). The sheet pile separated from the concrete wall at the north end of the site by splitting the webbed section rather than tearing the interlock.

Figure 4.9: Aerial view of the north breach of the Lower Ninth Ward (L. Harder, October 14, 2005).

Figures 4.9 and 4.11 show the emergency repair, consisting of a core of large sandbags overlain by embankment fill. The sandbags were airlifted into place, while the stone was placed from land. Owing to the presence of standing water on the landside during a visit on October 4, it was not possible to determine if seepage was occurring through the repaired section.

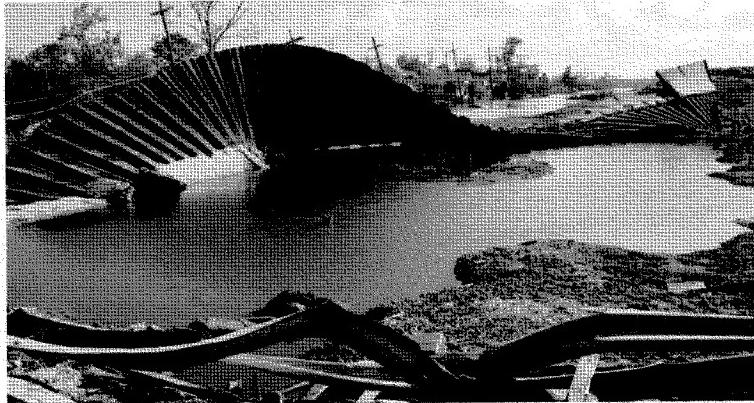
Figure 4.10: Overturned I-wall system at north breach of Lower Ninth Ward (J. Wartman, October 4, 2005).

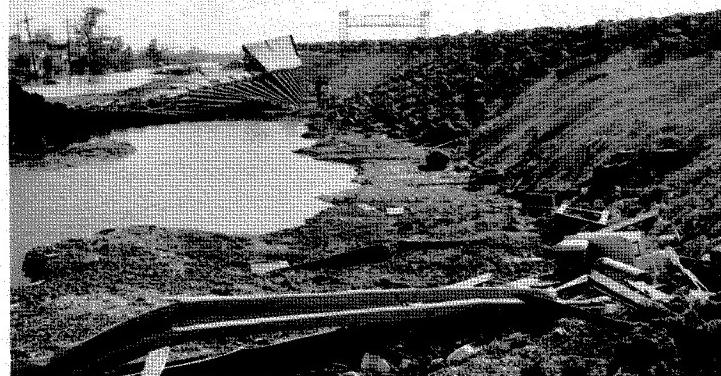
Figure 4.11: Looking south along the north breach repair at the Lower Ninth Ward (J. Wartman, October 4, 2005).

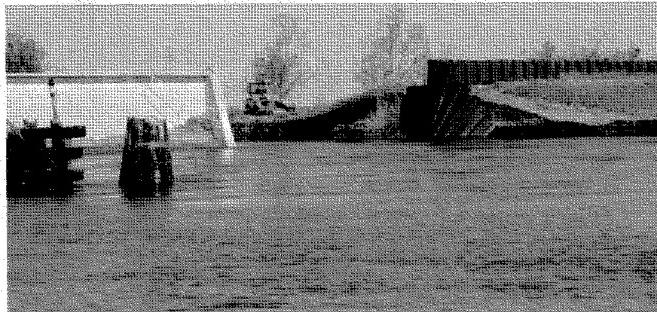
Figure 4.13 shows an approximately 80 feet long levee breach in the sheet pile section located immediately southeast of the gate structure. The earthen portion of the levee was completely obliterated and the sheet pile wall appears to have been torn from its connection southeast to the Bayou Bienvenue gate structure, and overturned. Representatives of the Orleans Levee District indicated that the gates were closed during Hurricane Katrina, and later reopened manually, due to the lack of electric power, after the storm had passed. Many of the sheet pile breach features were obscured by water at the site, and hence it was not apparent if the breach occurred due to a structural failure at the sheet pile gate connection, a result of overtopping, leading to scour and subsequent loss of passive resistance, or some combination of these factors. At the time of the last visit to the site on October 5, no repairs had been made to the breach.

Figure 4.13: Sheet pile breach at the Bayou Bienvenue Gate (J. Wartman, October 5, 2005).

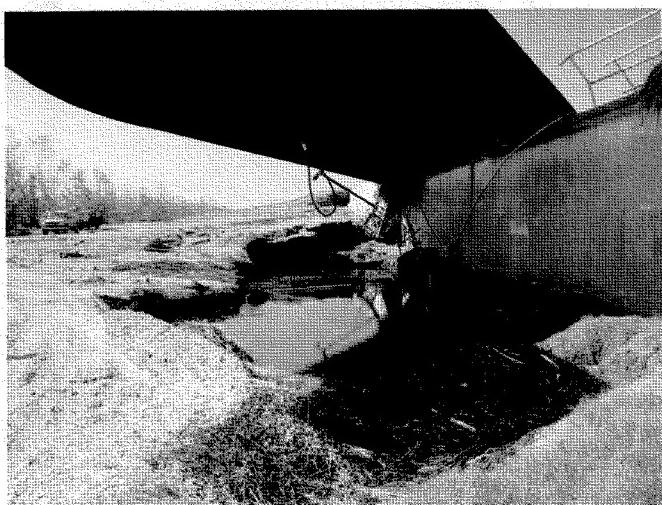
Figure 4.14: Scour near barge damage at the Bayou Bienvenue Gate site (J. Wartman, October 5, 2005).

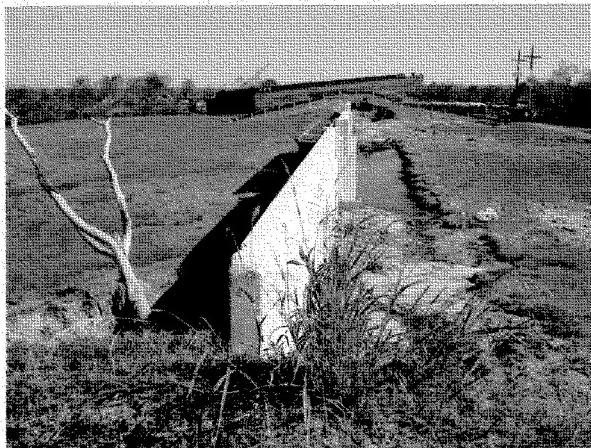
Figure 4.15: Scour near Bayou Bienvenue Gate site (L. Wooten, October 5, 2005).

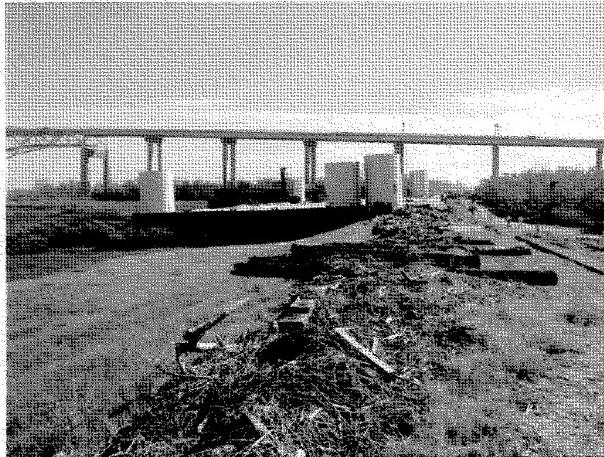
Figure 4.17: Debris line near levee crest just west of the Rt. 47 Bridge south abutment (L. Wooten, October 5, 2005).

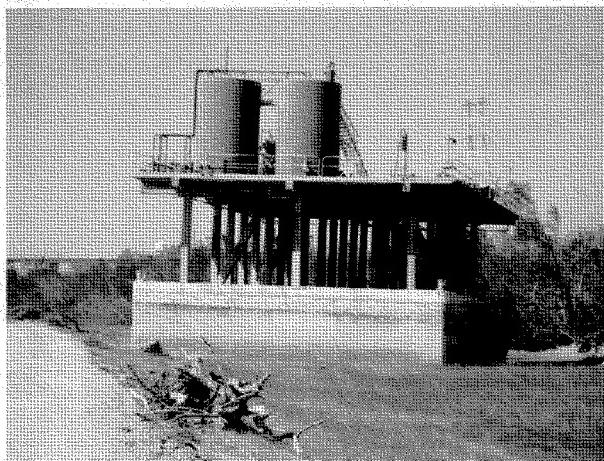
Figure 4.18: Various barges and other floating structures made contact with the earth levees without causing significant damage. Photo shows a gas processing barge (F. Silva, October 1, 2005).

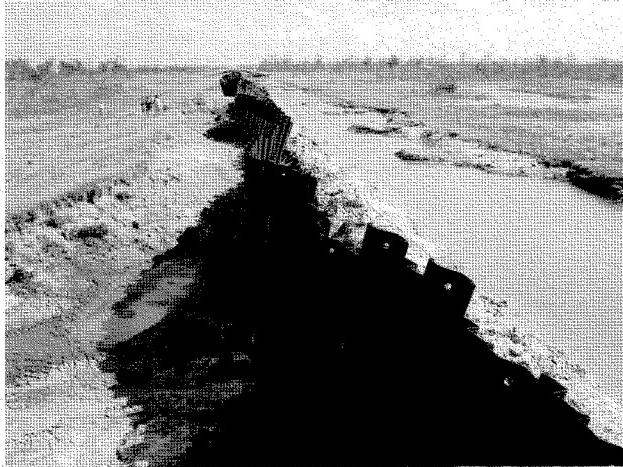
Figure 4.20: Failure of earth levee with steel sheetpile barrier on the southeast bank of the MRGO. Note severe erosion and scour (L. Wooten, October 6, 2005).

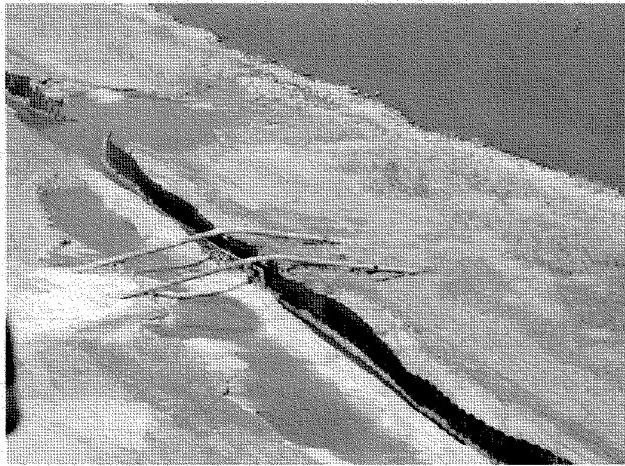
Figure 4.21: Levee failure on southwestern bank of MRGO between Bayou Bienvenue (where barge is aground on I-wall) and Bayou Dupree. Note severe erosion and scouring (L. Harder, October 14, 2005).

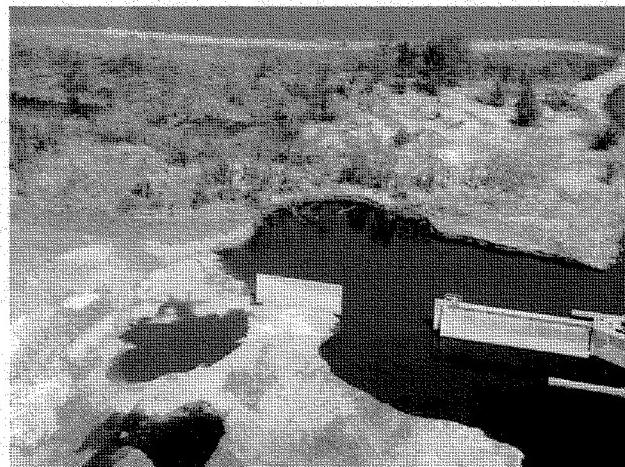
Figure 4.22: Levee failure on southwestern bank of MRGO at Bayou Dupree. Note concrete sheetpile and levee transition washouts (L. Harder, October 14, 2005).

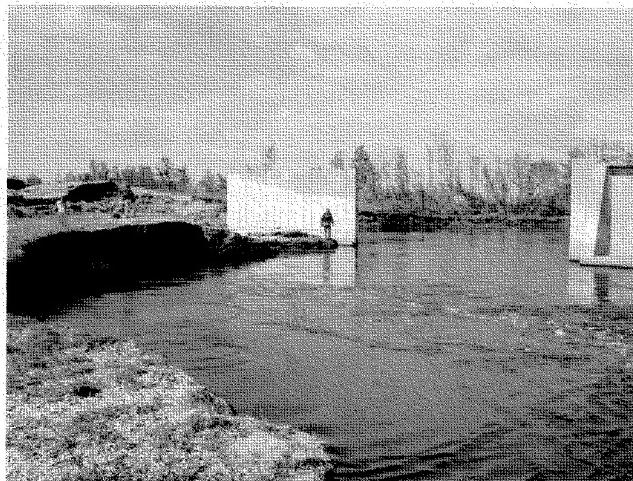
Figure 4.23: Ground perspective of Bayou Dupree gate abutment failure (L. Wooten, October 6, 2005).

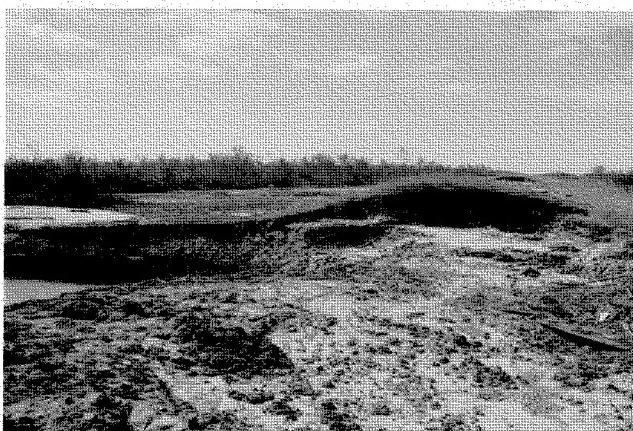
Figure 4.24: Failure of earth levee on southwest bank of MRGO adjacent to the Bayou Dupree gate (L. Wooten, October 6, 2005).

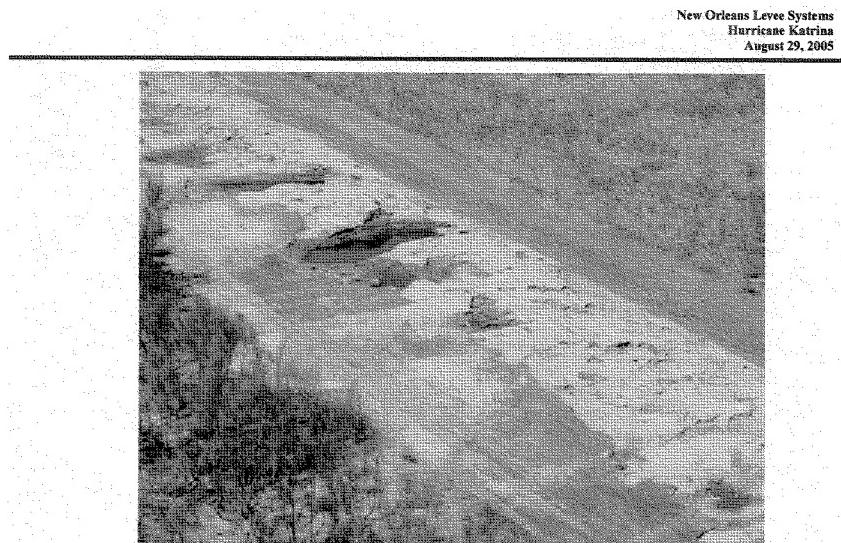
Figure 4.25: Overtopping obliterated earth levee along southwestern bank of MRGO, within two miles southeast of Bayou Dupree. Note deep scour at the levee foundation level (L. Harder, October 14, 2005).

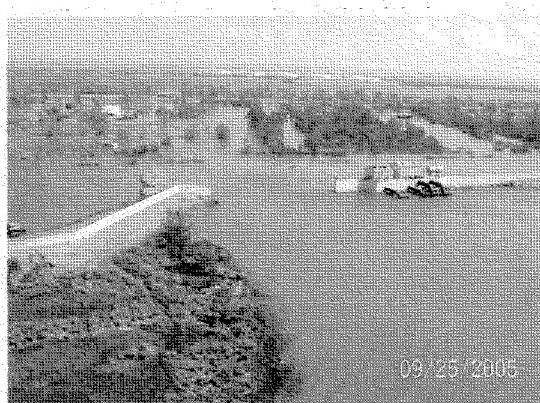
Figure 5.2: Aerial photograph of levee breach of hurricane (back) levee along western side of the Mississippi River near the community of Sunrise (September 25, 2005)

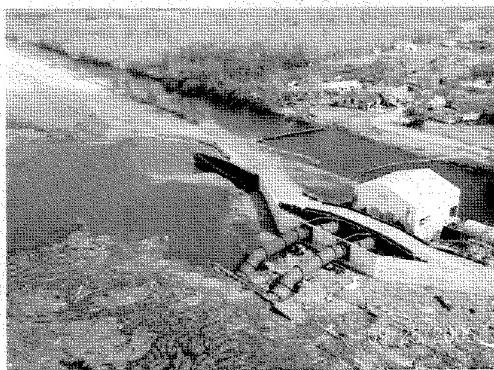
Figure 5.3: Aerial photograph of levee breach of hurricane (back) levee at levee transition near Hayes Pump Station (September 25, 2005)

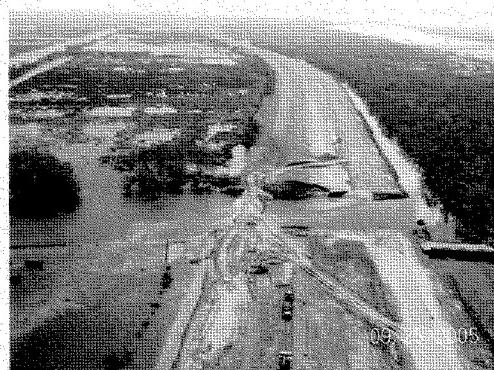
Pointe a la Hache is the parish seat for Plaquemines Parish and is located along the east side of the Mississippi River. Storm surges from the east largely overwhelmed the back levee, breached it in several places, and inflicted deep flooding and widespread destruction in this town. Figure 5.4 presents an aerial photograph of one such breach taken on September 25, 2005 (from Plaquemines Parish Government Website). Shown in this photograph is a temporary road constructed across the breach to facilitate access and repairs.

Figure 5.4: Aerial photograph of levee breach of hurricane (back) levee east of Pointe a la Hache (September 25, 2005)

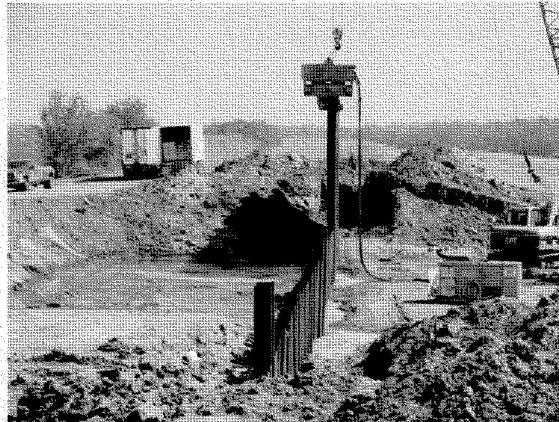
Figure 5.5: Photograph of sheetpile cutoff being placed into levee breach of hurricane (back) levee east of Pointe a la Hache (October 12, 2005)

Figure 5.5 shows this same levee breach a few weeks later during the installation of a sheetpile cutoff that was undoubtedly intended to be part of an interim, and perhaps permanent repair. The team members viewing the installation believed that the sheetpile wall was a good concept to effect a positive cutoff of seepage through the deeply scoured breach and loose debris. However, during the installation, team members noted that the contractor was having difficulty advancing the southern portion of the sheetpiles very far into the ground with the equipment in use at the time of the team's visit. It is not known how the contractor resolved this situation.
